**BLACKSTONE RIVER BASIN
AUBURN, MASSACHUSETTS**

**STONEVILLE POND DAM
MA 00126**

**PHASE I INSPECTION REPORT
NATIONAL DAM INSPECTION PROGRAM**

AUGUST 1978

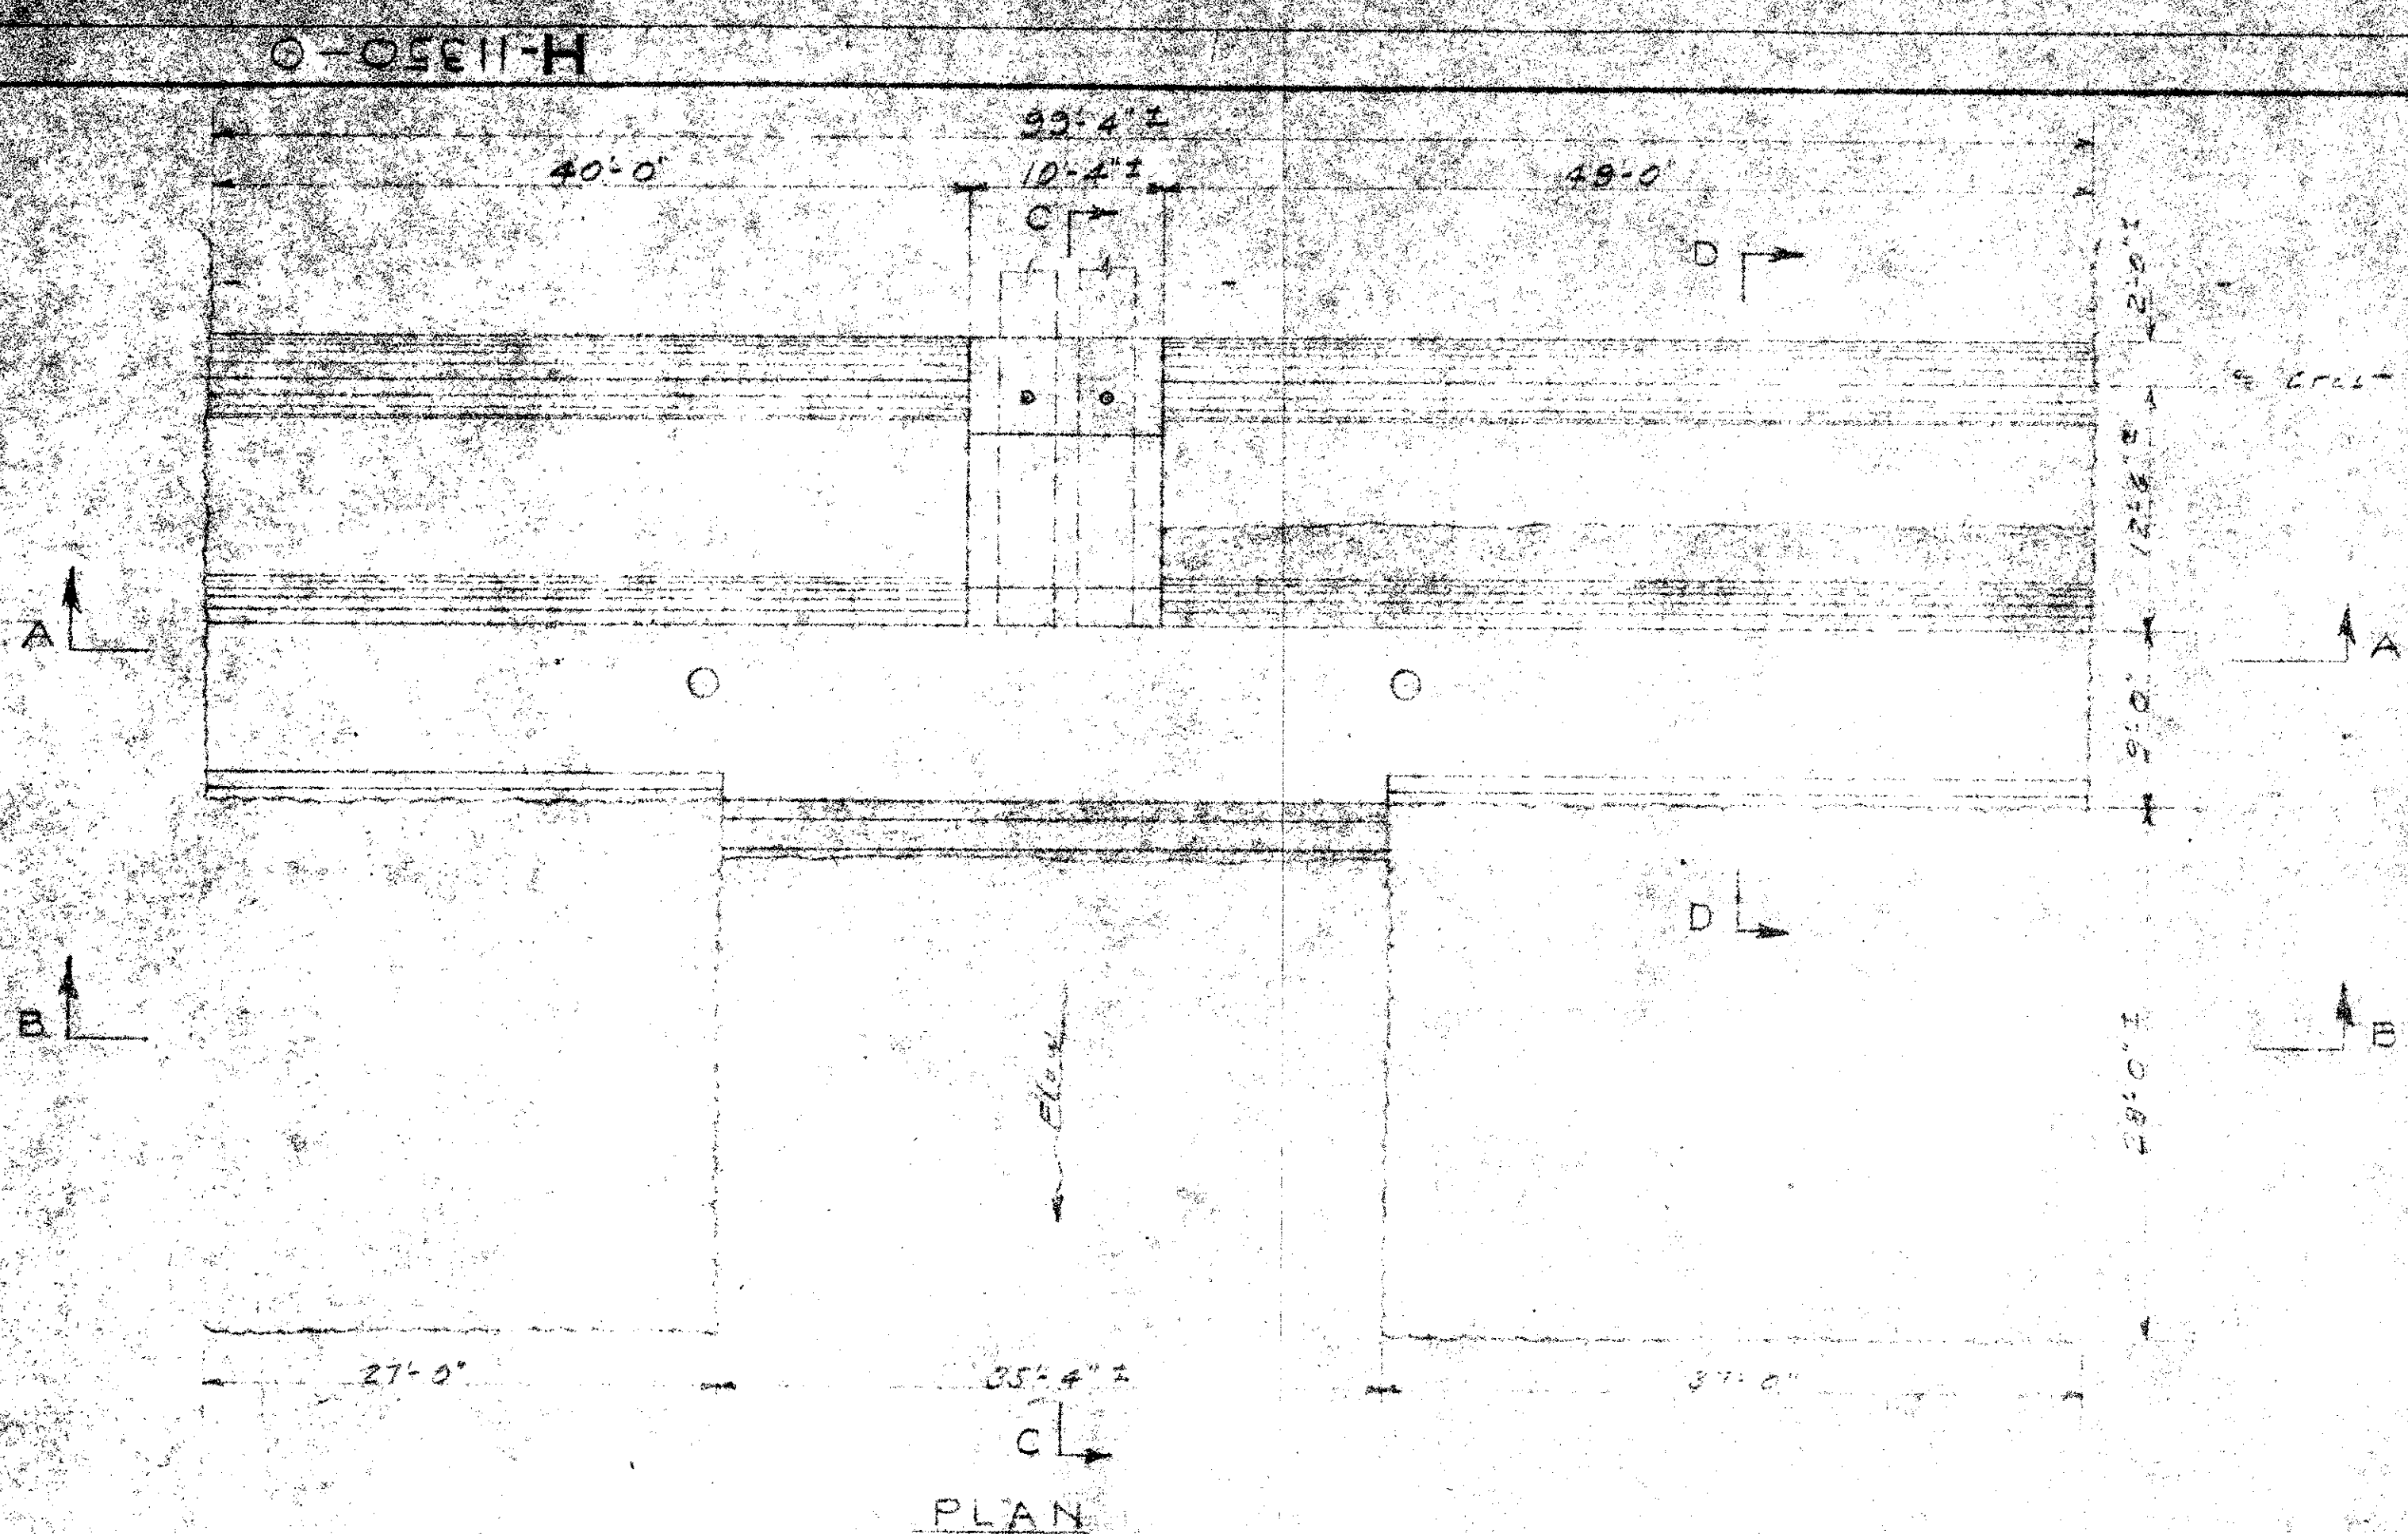
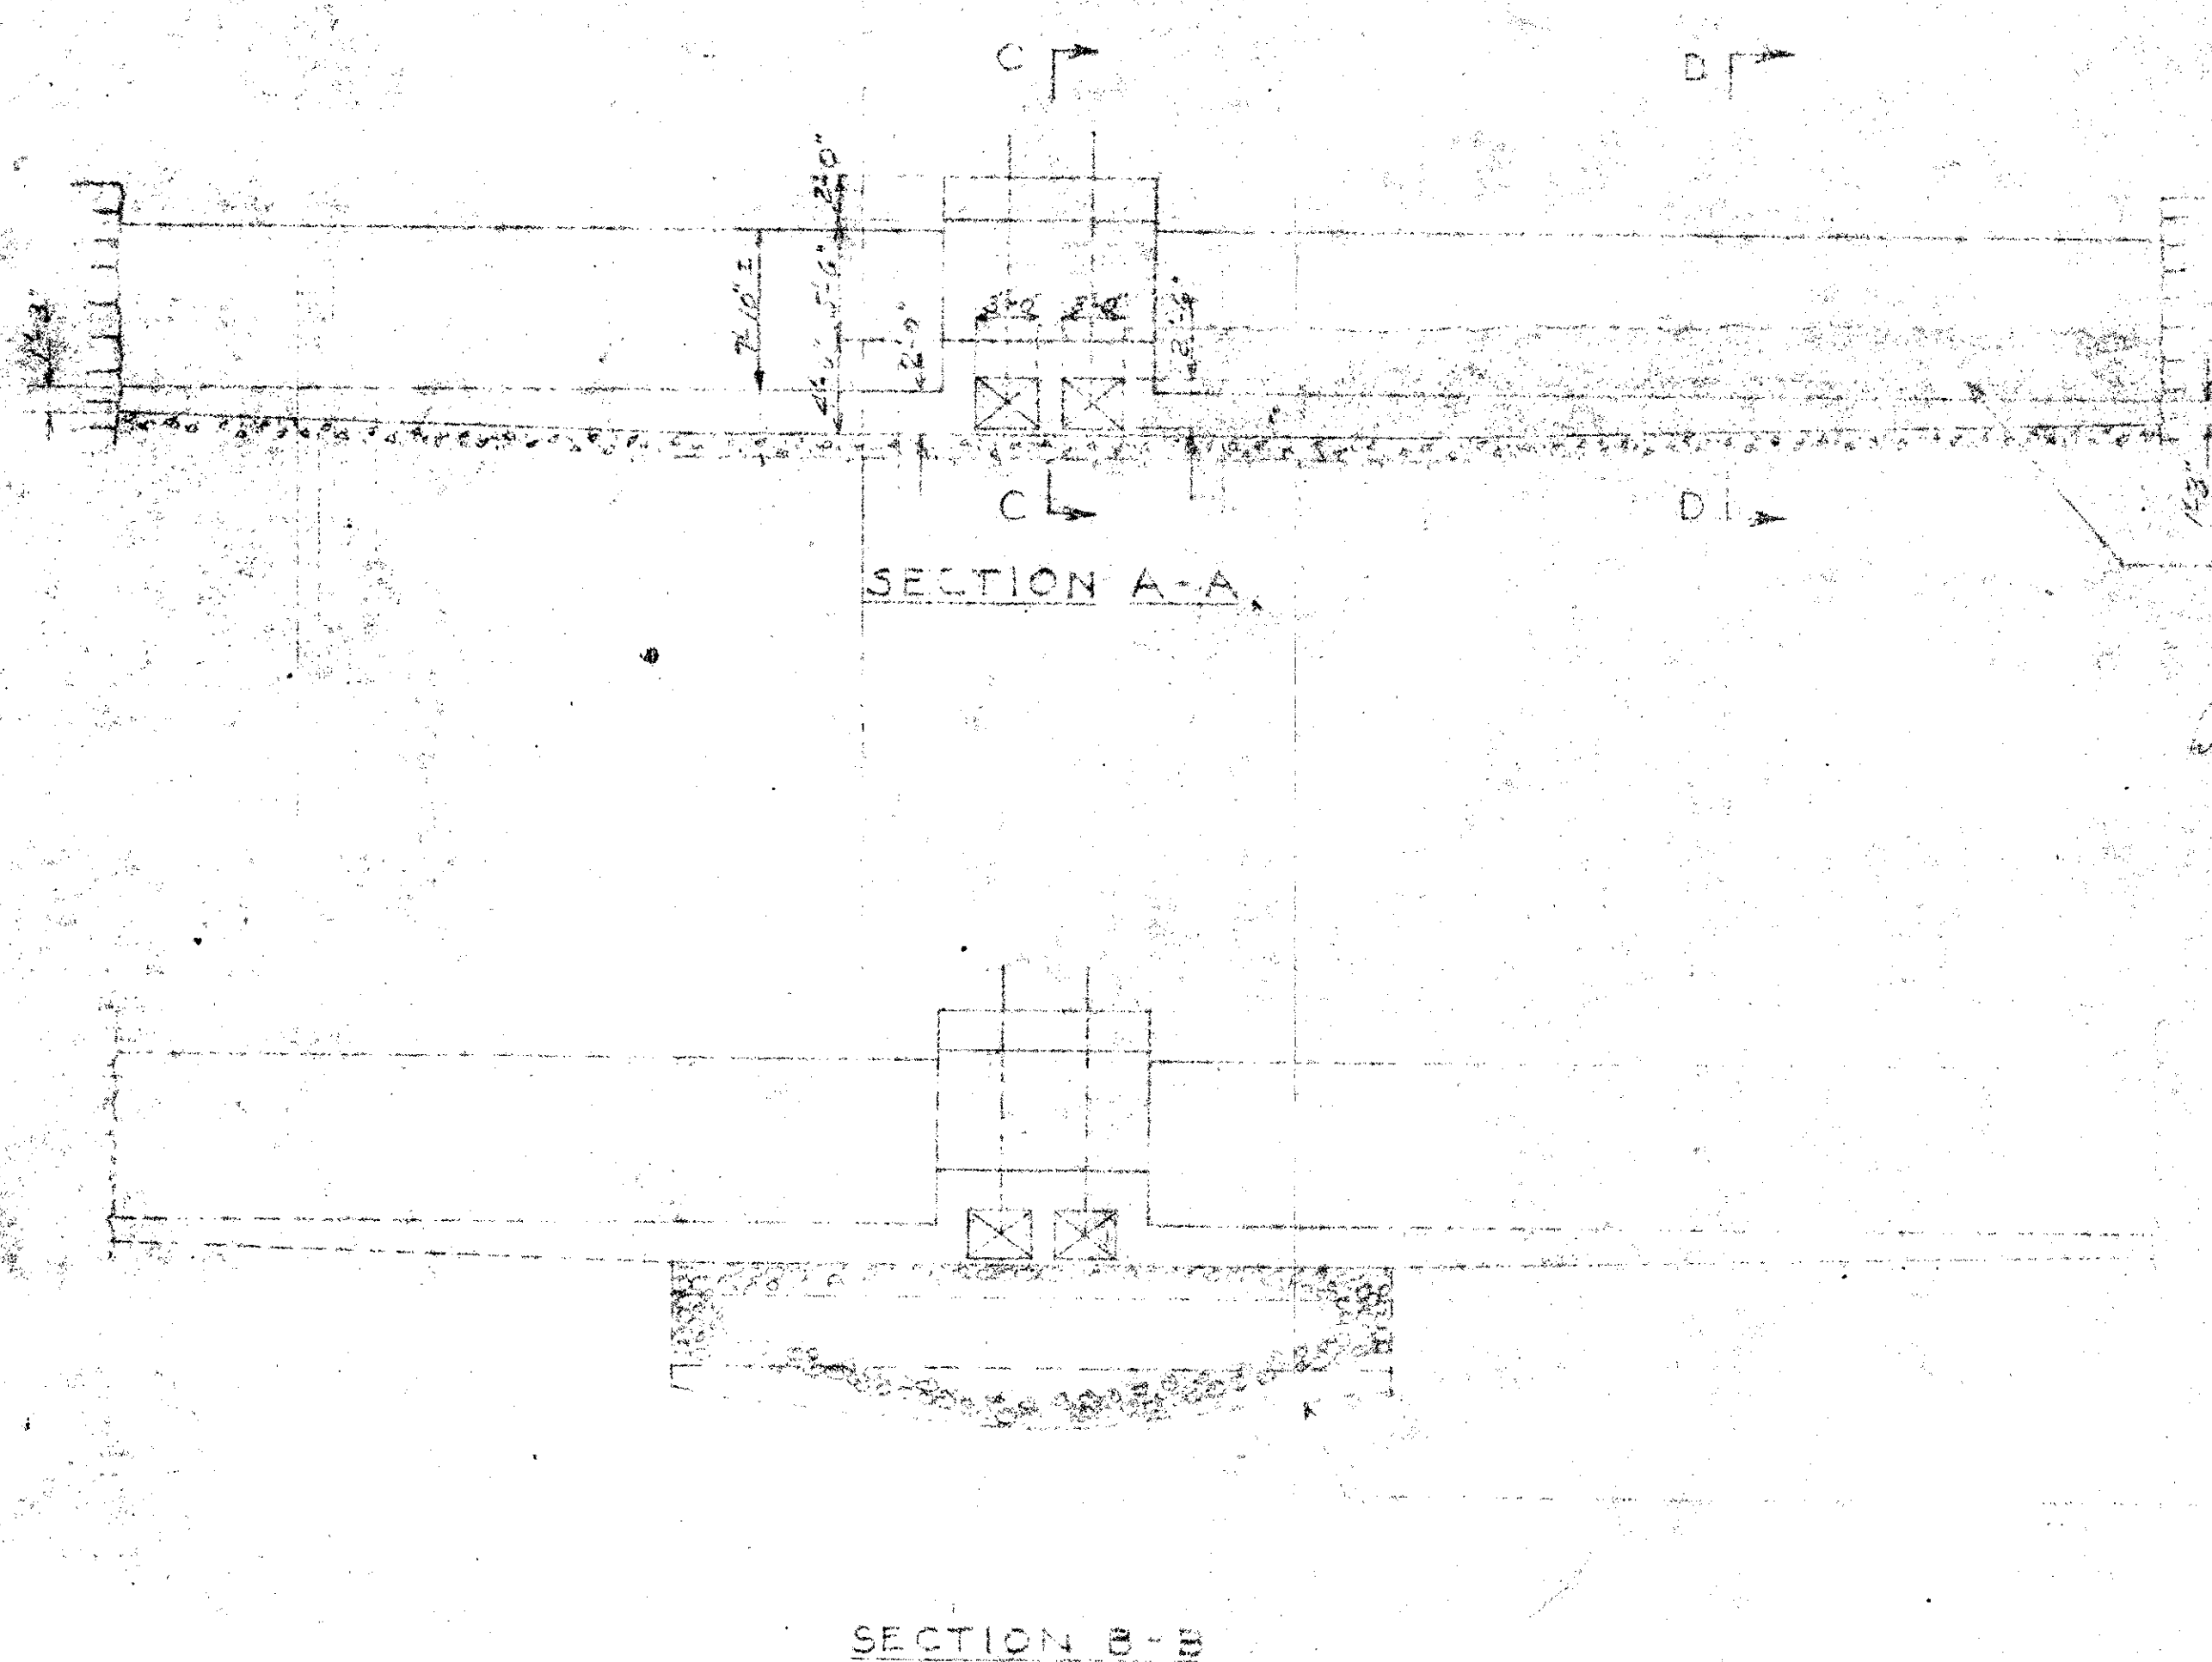
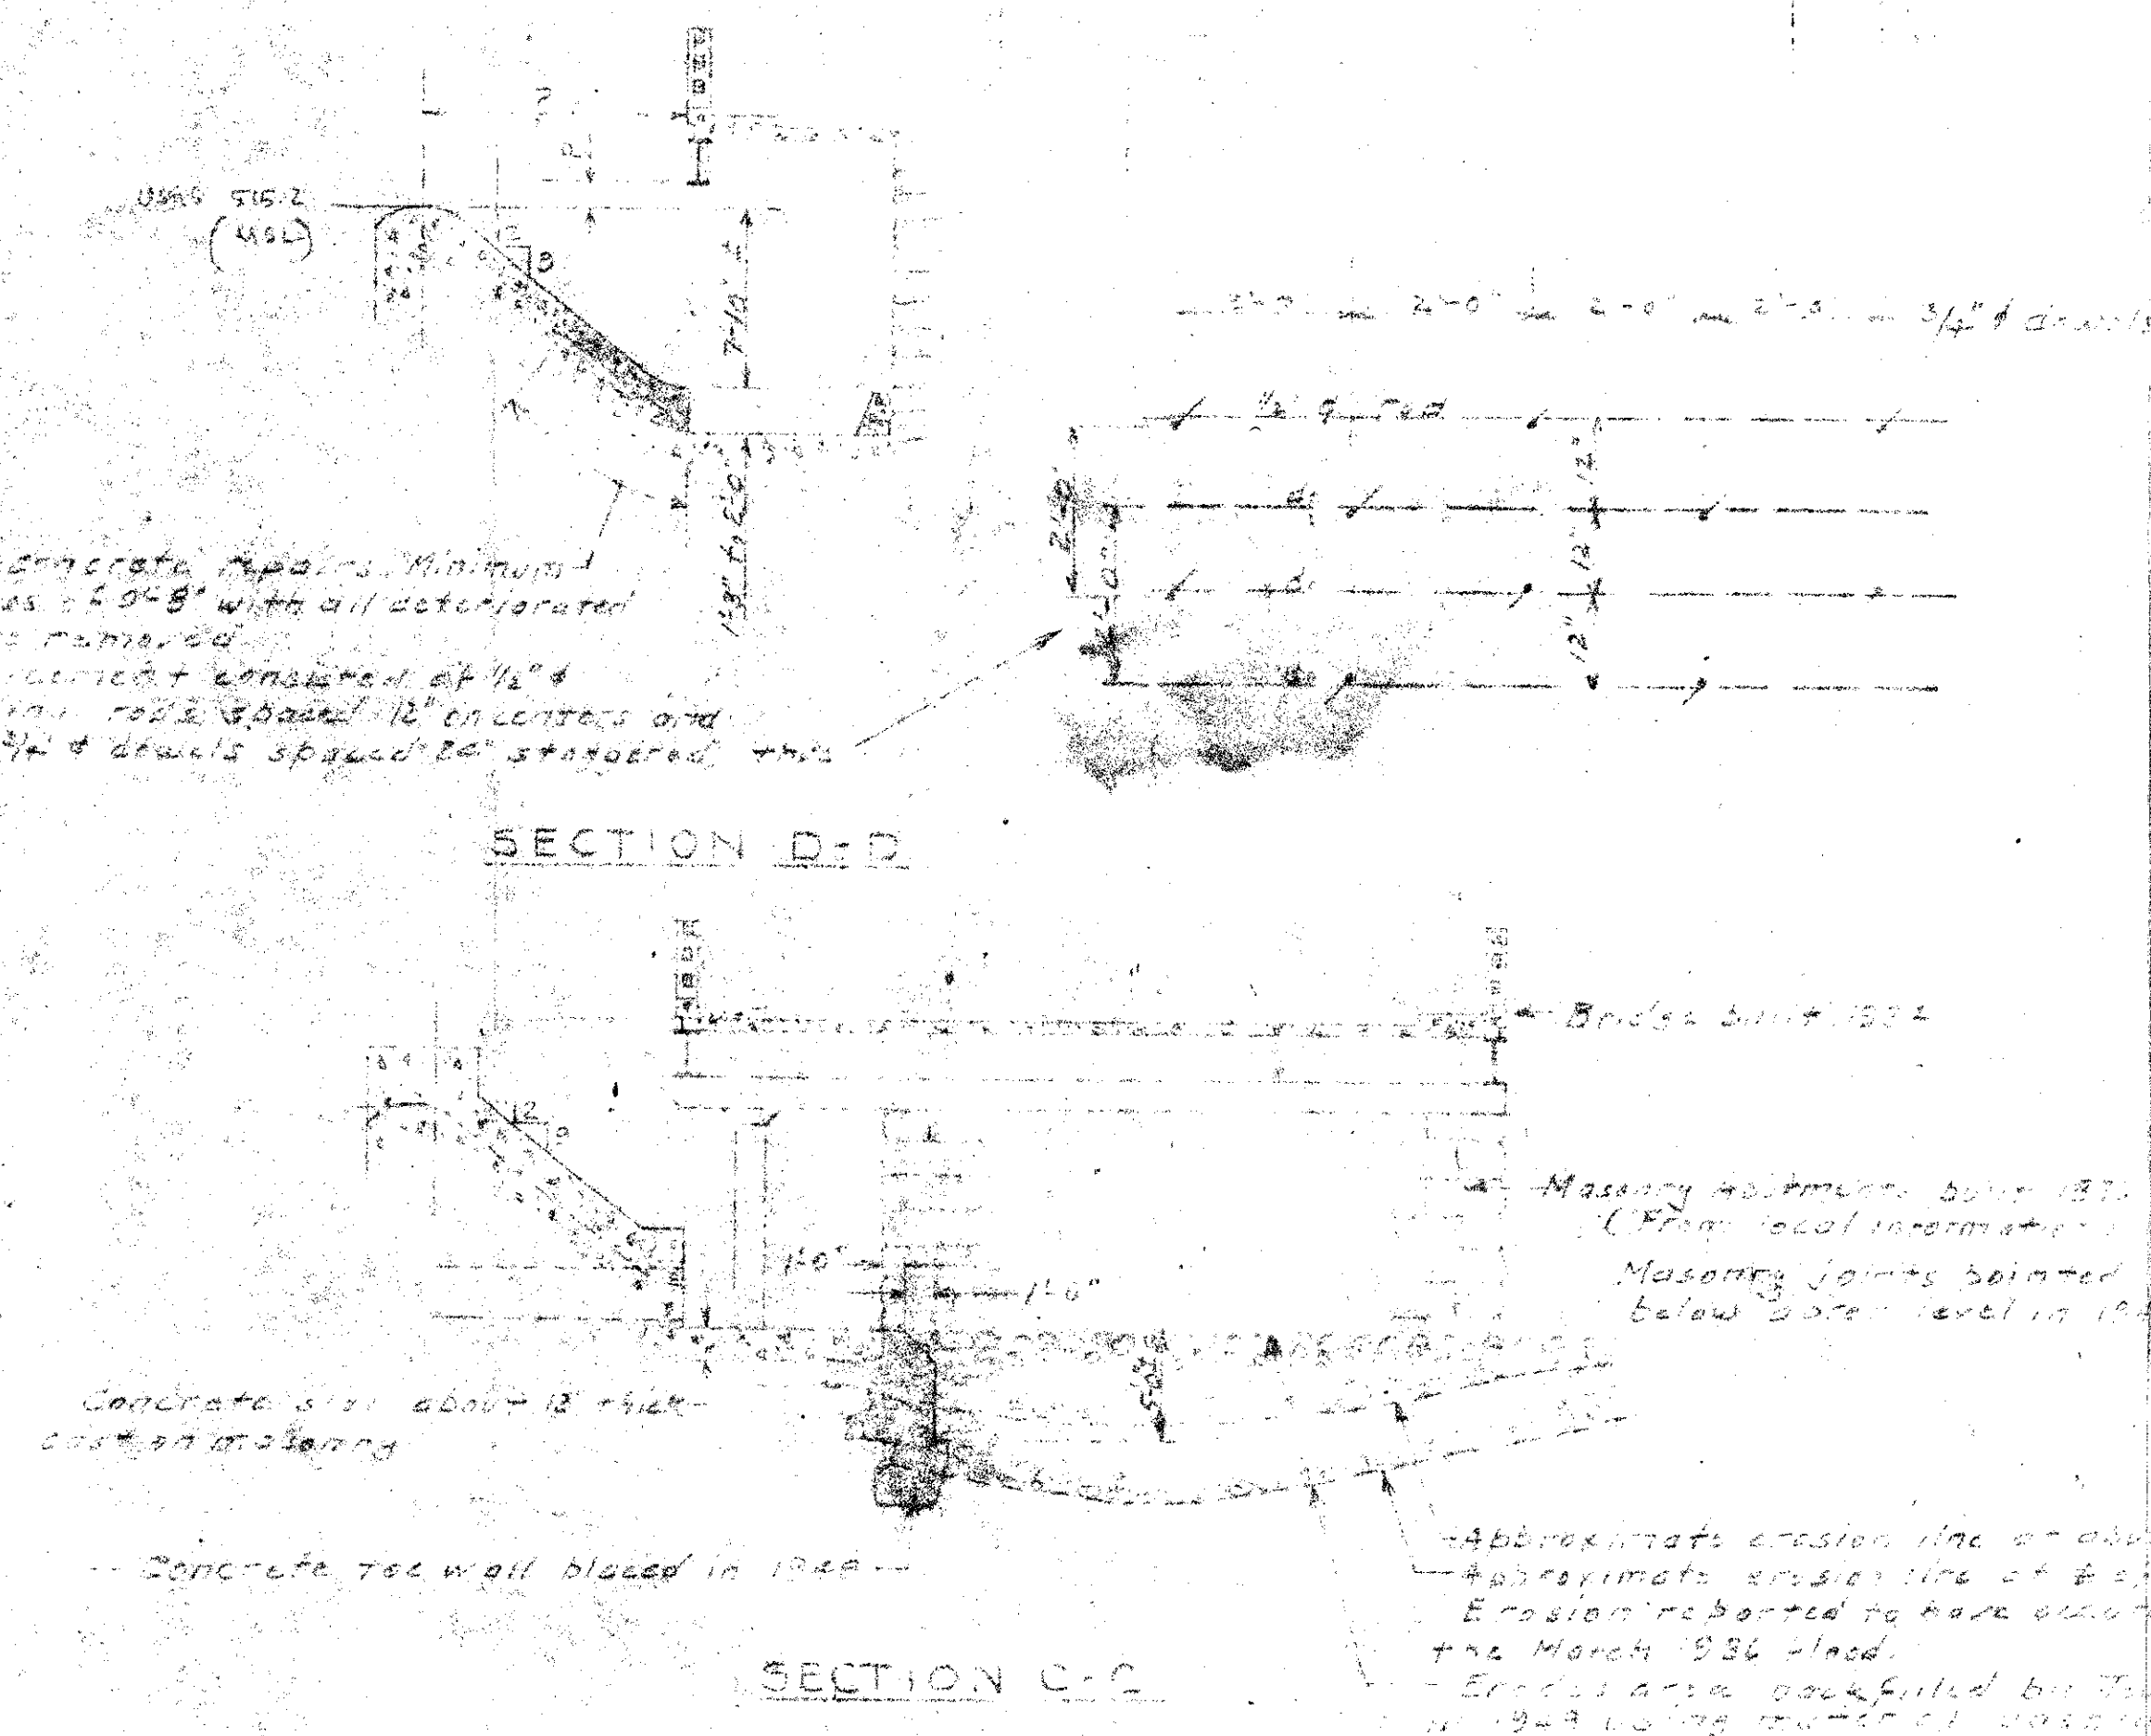
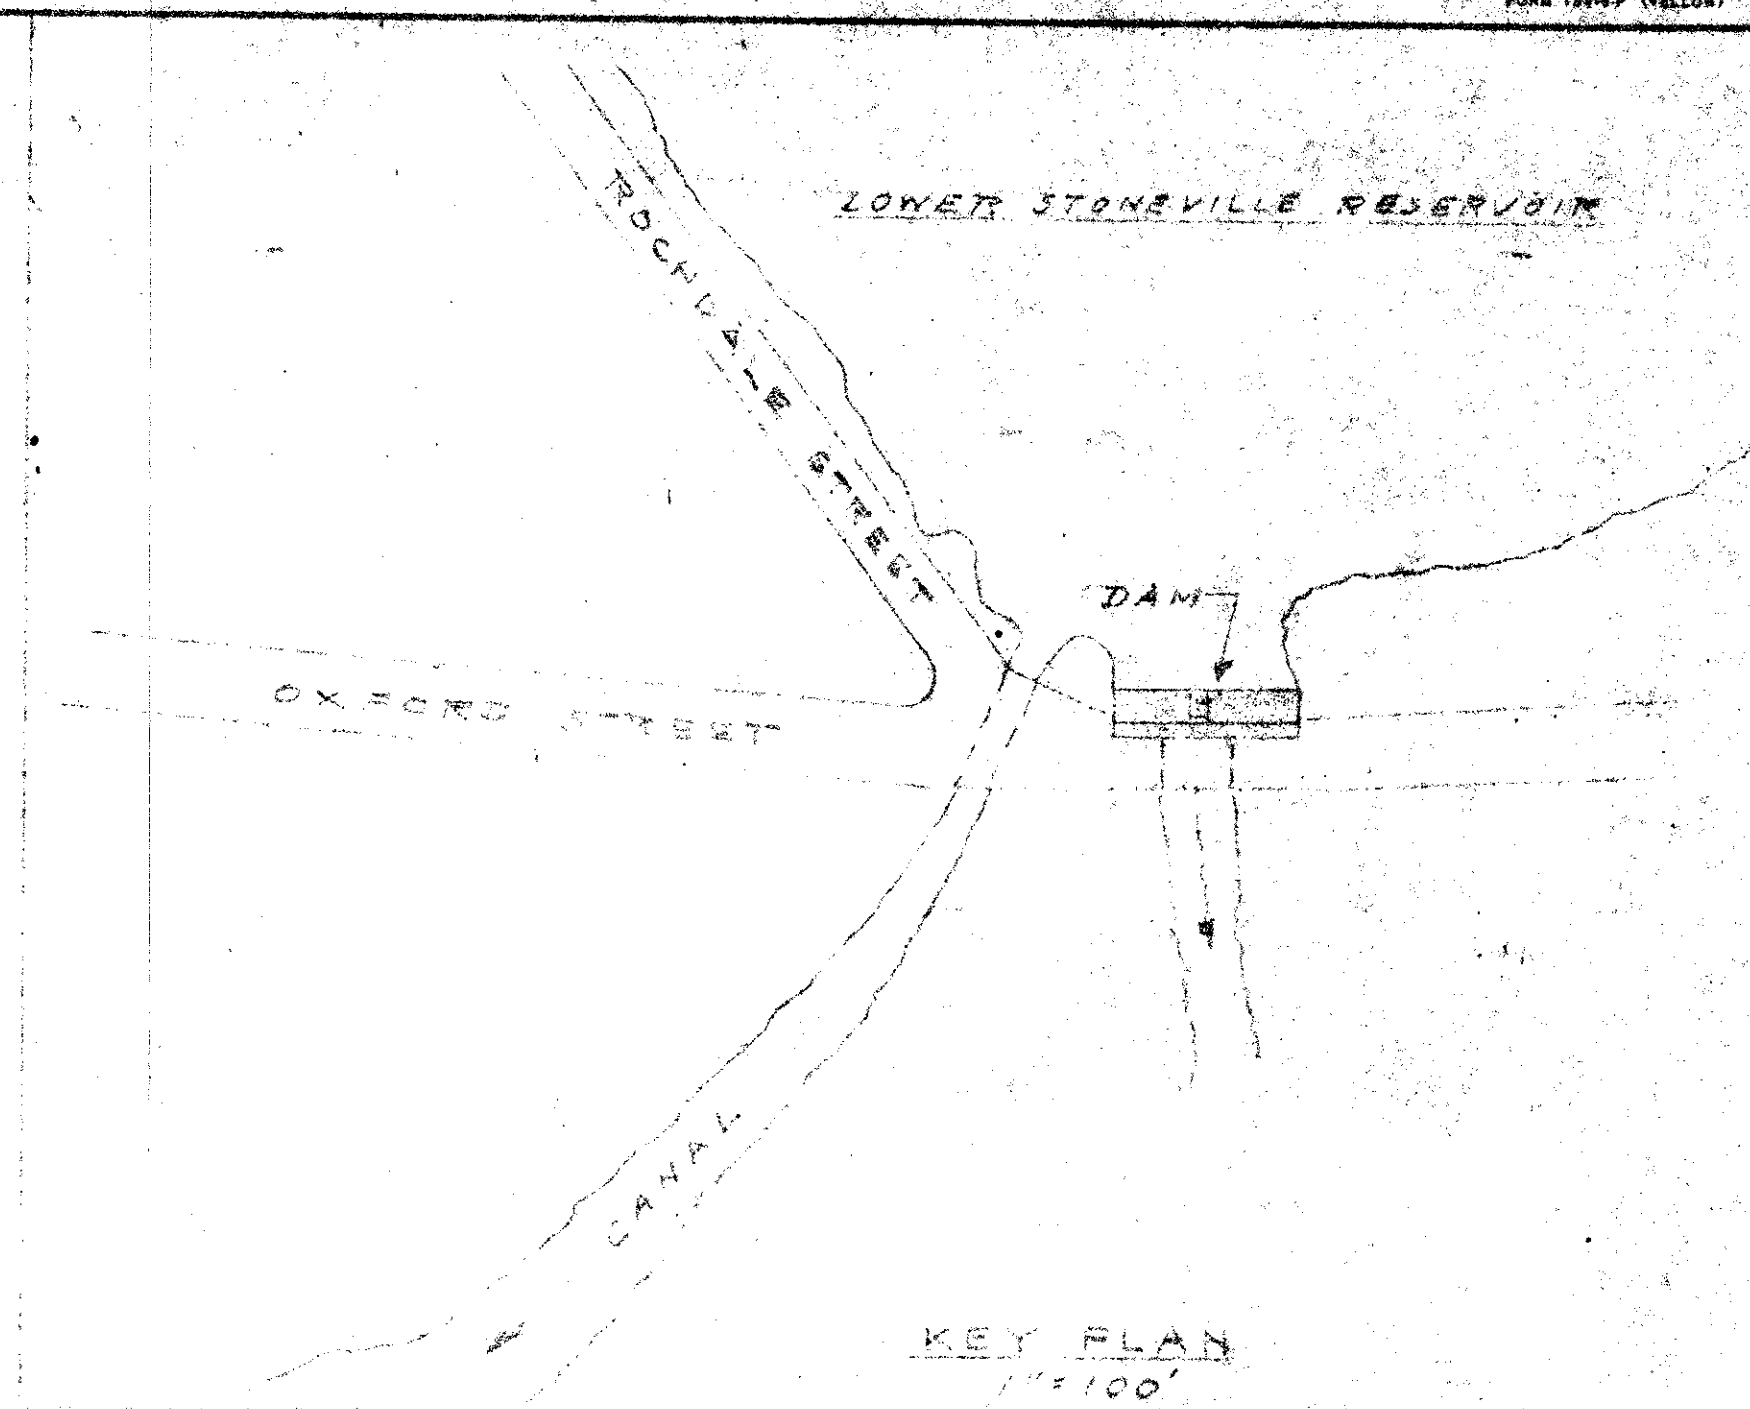
DETAILS OF DAM
SHOWING 1948 REPAIRS

Also in 1948 major repairs were made to the spillway section. A minimum 8-inch thickness of reinforced concrete replaced the deteriorated concrete face on the north section of the lower slope of the ogee weir. A 12-inch concrete slab was placed on the masonry at the toe of the weir, and a concrete toe wall was placed between the masonry abutments. Apparently there were flashboards on the weir at one time, but there is no evidence of them now.

1948 concrete repairs. Minimum thickness 10" with all deteriorated concrete removed. Rebar placed + consisted of 1/2" long main rods spaced 12" centers and wired to 1/4" diameter spaced 12" staggered.

Concrete toe wall placed in 1948.

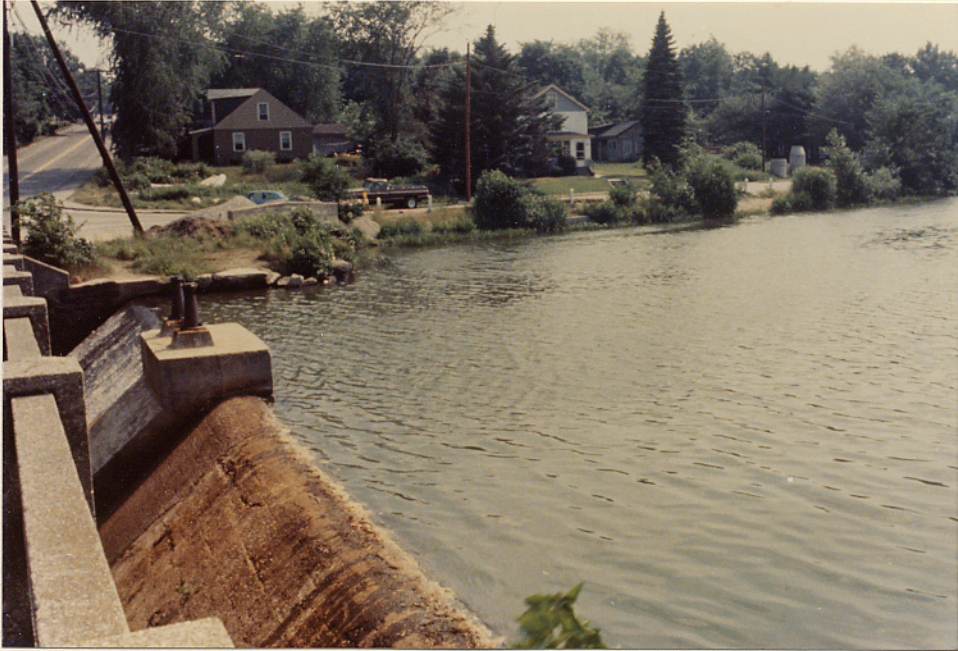
**NO. 1 VIEW OF SPILLWAY CREST AND
SOUTH ABUTMENT**

- c. Appurtenant Structures. The concrete and stonework of the spillway are in poor to fair condition. Pieces of the dry stone masonry training wall at the south abutment are dislodged. Some of the masonry of the spillway sidewalls is missing, and there is a crack in the concrete cap over the north sidewall. At the time of the inspection, water was flowing over the south section of the ogee weir.

The concrete facing of the spillway is eroding away, and there are local areas of cavitation, and heavy staining of the surface. Slight to moderate seepage was noted on the north and south masonry abutments under the bridge along the spillway channel. The concrete slab of the channel is in fair condition with an irregular, eroded surface and evidence of severe cavitation on the upstream section of the slab. The downstream channel has some stone placed on its banks for about 80 feet, and the channel is relatively clear except for a few overhanging bushes and construction debris on the south bank.

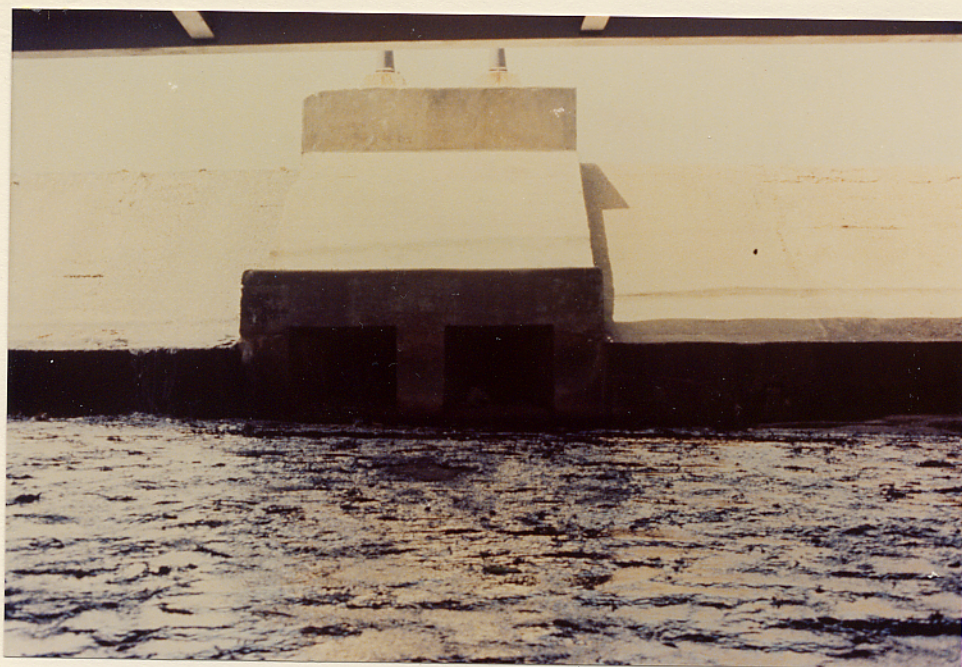
NO. 3 VIEW OF SPILLWAY AND OUTLET

The outlet structure is in poor condition. The inlet is not visible. The gate structure on the weir shows minor spalling and efflorescence on the concrete and some cracking as well. The two gate stems on the concrete are reportedly inoperable. Presently, the only access to the gates is across the crest of the weir, which makes the gate control mechanism entirely inaccessible during high flows.

The outlet from the gate structure is a double concrete box conduit that discharges at the toe of the spillway. The closed gates are not visible and there is no leakage. The concrete is in poor condition, showing evidence of spalling, erosion, and moderate cracking.

- (1) repair the gate mechanisms to make the slide gates operable and construct some form of access walk to them,
- (2) repair the concrete on the weir and on the outlet structure,
